STATE OF HAWAII
DEPARTMENT OF LAND AND NATURAL RESOURCES
Division of Aquatic Resources
Honolulu, Hawaii 96813

SUBJECT: (1) Report and Assessment of Coral Damage of the Keawakapu Artificial Reef Incident; (2) Evaluation of the Coral Damage; and (3) Issuance of a Fine Against American Marine Corporation for Damage to Coral, Live Rock and the Environment on Unencumbered Submerged Lands in the Conservation District

DATE OF INCIDENT: December 2, 2009

LOCATION OF DAMAGE: Keawakapu Reef, Maui, Hawai'i

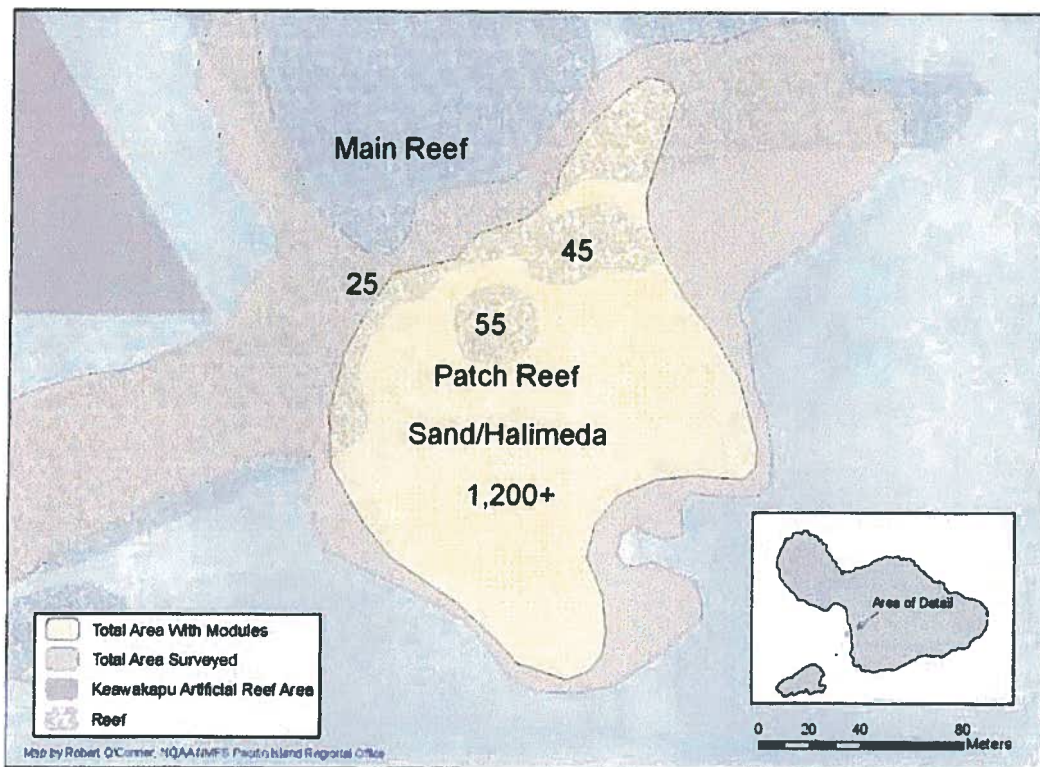
Of the reported 1400 modules deployed, 125 were found to have landed partially or totally on coral reef habitat (Figure 2). All modules that landed on coral reef habitat were of the Z-module form; no hollow cube forms landed on reef. The remaining modules landed on sand or sand with beds of *Halimeda sp.* algae. The total area of the module deployment (including modules that landed on the reef) measured approximately 5 acres (~20,000 m²). The majority of modules did not land on the reef, but dive teams surveyed a larger area to ensure all modules were accounted for. The total area surveyed for injury (estimated from the track logs and spatial maps) was approximately 12 acres (~ 50,000 m²) (Figure 2). During the survey reef injuries from modules were discovered in two habitat areas, a main reef, and an adjacent patch reef. Surrounding these two habitat areas to the south, west, and north was sand and beds of *Halimeda sp.* algae (Figure 2). These areas are discussed in more detail below.

Figure 2. A detail map showing the area surveyed during the three-day pre-assessment project and the spatial extent of the module deployment. The numbers denote the number of modules found on the main reef (25), the extension from the main reef (45), and the patch reef (55). The remainder of the modules (1,200+) was found on sand or sand with *Halimeda sp.* habitat. The southeast corner of the designated Keawakapu Artificial Reef area can be seen on the top left of the map.

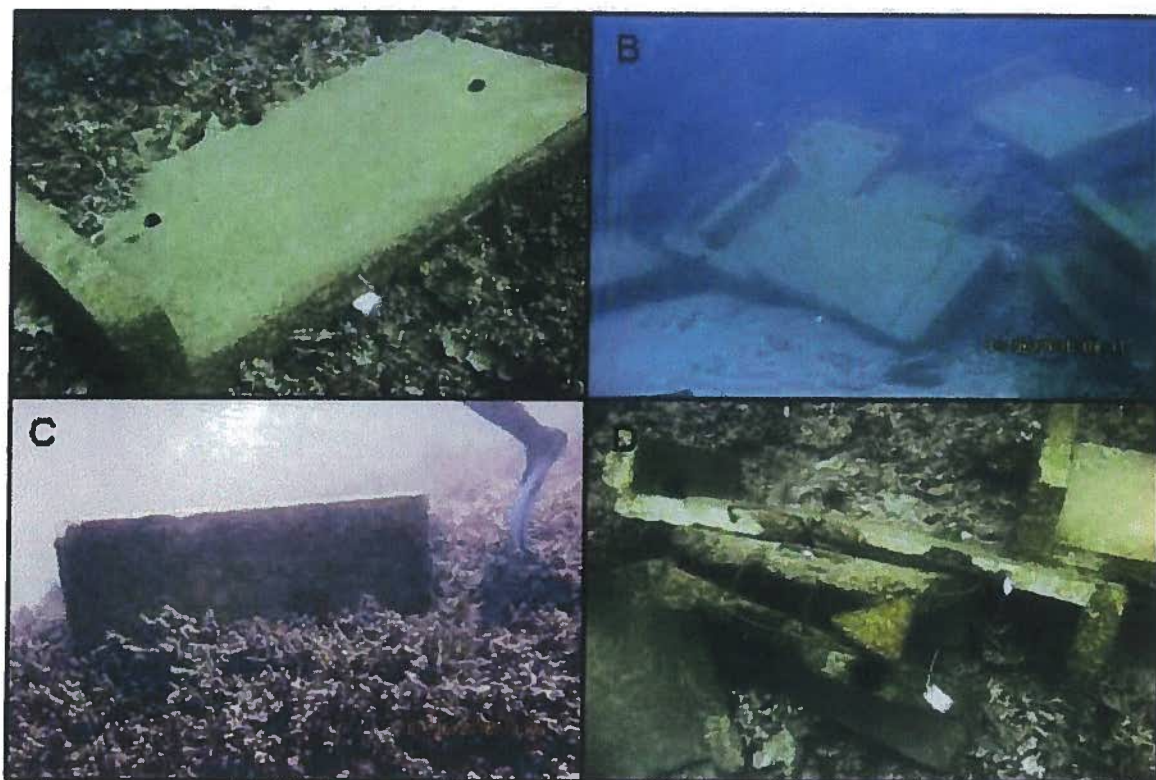
Figure 3. Four representative module orientations found on the reef.

Modules were observed in a wide variety of orientations in all of the habitats. In general the configurations fell into four basic categories: (1) individual modules lying horizontally flat on the substrate (Fig. 3A), (2) several modules stacked together either partially or wholly overlapping each other (Fig. 3B), (3) modules lying partially or fully on edge (Fig. 3C), (4) fragmented and damaged modules (Fig. 3D).

A) An individual solitary module lying flat along one face.

C) An individual module lying upright along its long axis.

D) A cluster of modules showing signs of substantial collision with the reef (modules are fragmented and broken). A perimeter of broken coral can be seen surrounding the cluster indicating that the modules slid after impact.

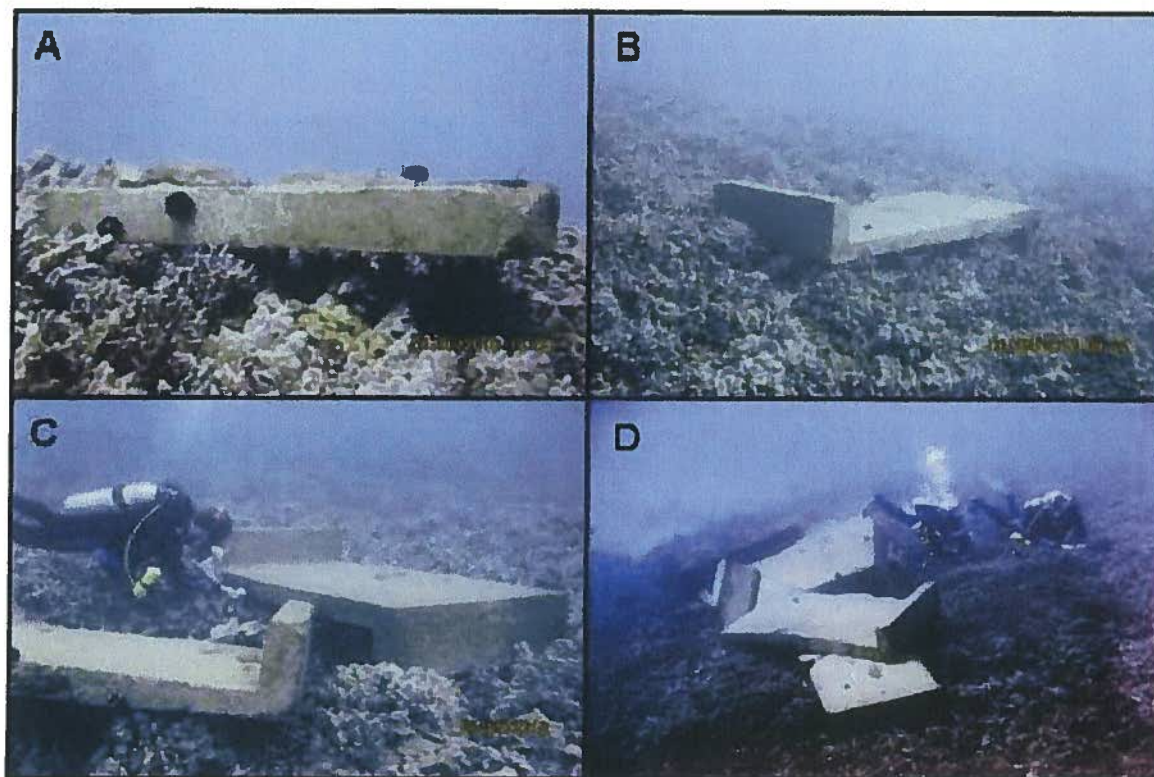
Figure 4. Modules found on the main reef area.

The main reef in the survey area is part of a reef complex extending to the north and east (Figure 2). The section of main reef surveyed for injury was a ridge approximately 300 ft (~ 100m) wide (north/south) and at least 1500 ft (~ 500 m) long (east/west). The top of the main reef was in approximately 50 ft (~ 17 m) of water with the north side of the ridge sloping to > 100 ft (~ 33 m) and the south edge sloping to approximately 70 ft (~ 23 m). Twenty-five modules were concentrated in a central portion of the main reef on the southern edge of the area surveyed (Figure 2). The condition of the modules in this area varied. Some modules were undamaged and appeared to have impacted the bottom with relatively little physical force (Fig. 4A), but others were damaged, suggesting a greater

impact force with the bottom (Fig. 4B, 4C). Most modules in this area of reef were solitary or in pairs, but a few small clusters of modules were observed (Fig. 2D). The density of modules found in this area was low.

A) An individual module that appears to have settled on the reef without breaking all the coral underneath it. Intact coral can clearly be seen underneath the module, supporting its weight. Shading under the module is evident in the photo and will likely result in some coral mortality.

B) A solitary individual module showing a crack across the top indicating that it may have settled with substantial force.

C) A pair of modules on the main reef that was representative of the typical density of the modules in this area. Note intact coral can be seen under the module in the foreground.

D) A cluster of cracked and broken modules that was atypical of the density of modules in the main reef area.

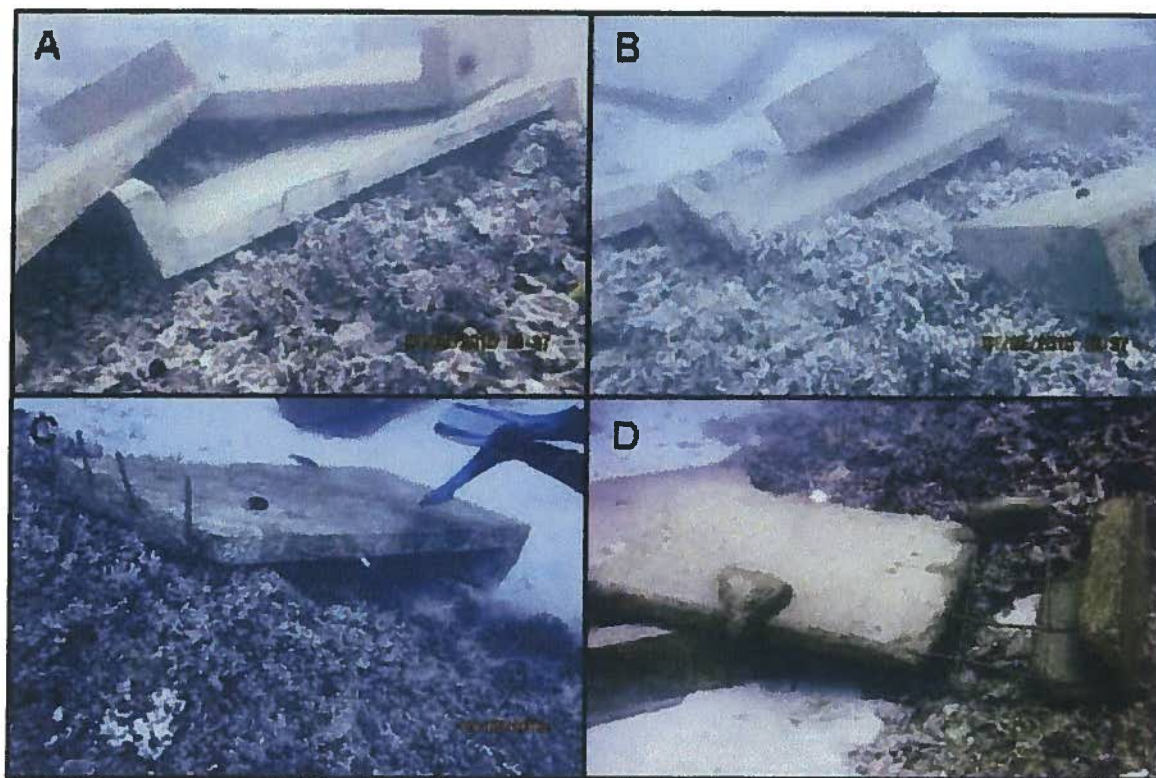
Figure 5. Modules found on the extension of the main reef.

An extension of the main reef was impacted by 45 modules with the majority of modules located along the southern edge (Figure 2). This oblong extension of reef was located on the eastern section of the surveyed area of main reef. This portion of reef was attached to the main reef at approximately 50 ft (~17 m) depth, extending southeast and sloping to the sand bottom at 70 ft (~23 m). The density of the modules on this extension was greater than that found on the main section of reef, and modules were frequently observed in overlapping clusters (Fig. 5A, 5B). Some modules were also clustered along the southern margin of the reef protrusion lying partly on sand, and several showed indications of substantial collision force with the substrate (Fig. 5C, 5D).

A) An overlapping cluster of modules on the extension of the main reef. Broken coral can be seen in a perimeter around the modules indicating that they slid down slope causing additional injury to coral.

C) A module lying partially on reef and partially in sand. The edge of the module has been broken off exposing the internal rebar structure.

D) Overlapping modules lying partially in sand. The top module has been broken exposing the internal rebar framework. Module fragments can be seen nearby.

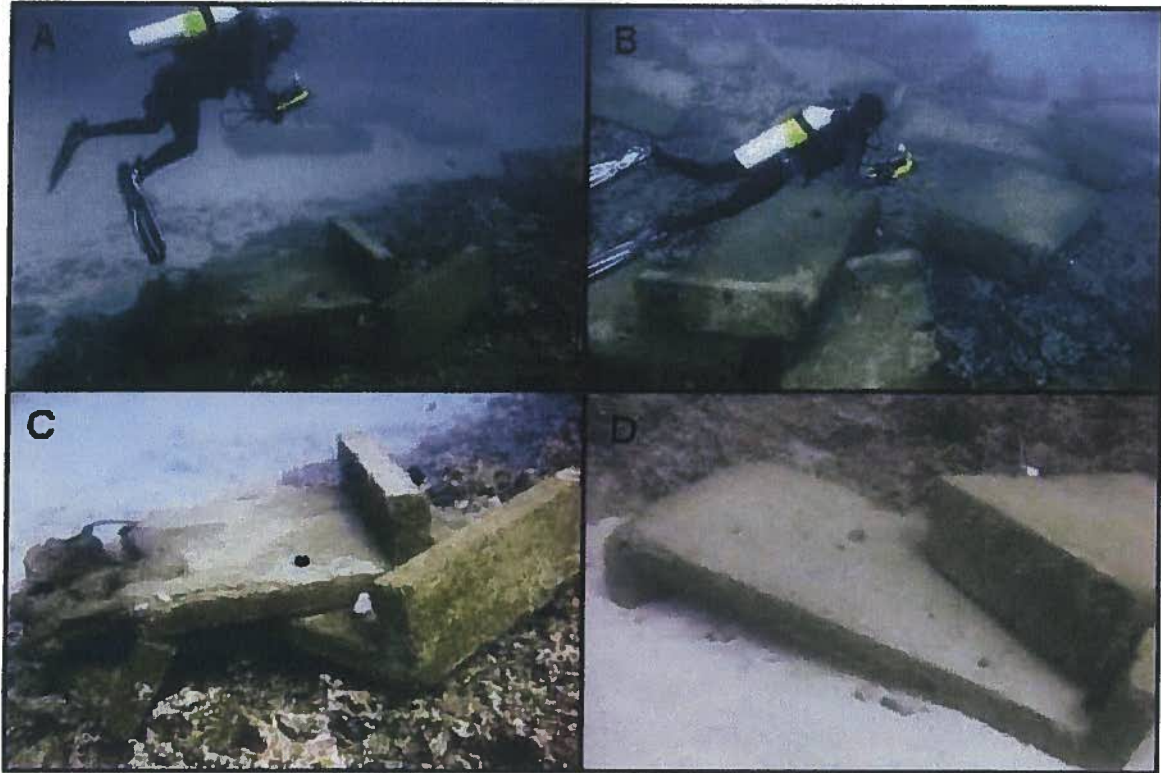
Figure 6. Modules found on the patch reef.

Modules were also observed on a patch reef just south of the main reef (Figure 2). The patch reef was approximately 150 ft (~ 50 m) in diameter with the top at 50 ft (~ 17 m) depth and sloping to the sand bottom at 70 ft (~ 23 m). Fifty-five modules were clustered on the patch reef (Fig. 4A, 4B). Modules were observed across most of the patch reef. Many of the modules appeared to have experienced substantial collisions with the substrate and appeared to have slid down the reef slope causing additional damage to coral (Fig. 6C). Some modules lay partially in the sand at the reef/sand margin around the perimeter of the patch reef (Fig. 6D). Most of the hollow cube modules were found isolated and in clustered formation to the east and south of the patch reef.

A) Overlapping modules on coral.

C) An overlapping cluster of modules showing signs of substantial collision with the reef. The modules are broken and a perimeter of injured coral can be seen surrounding the modules indicating that they slid down slope.

D) An overlapping cluster of modules along the reef/sand margin of the patch reef. The modules are lying partially in sand and partially on reef.

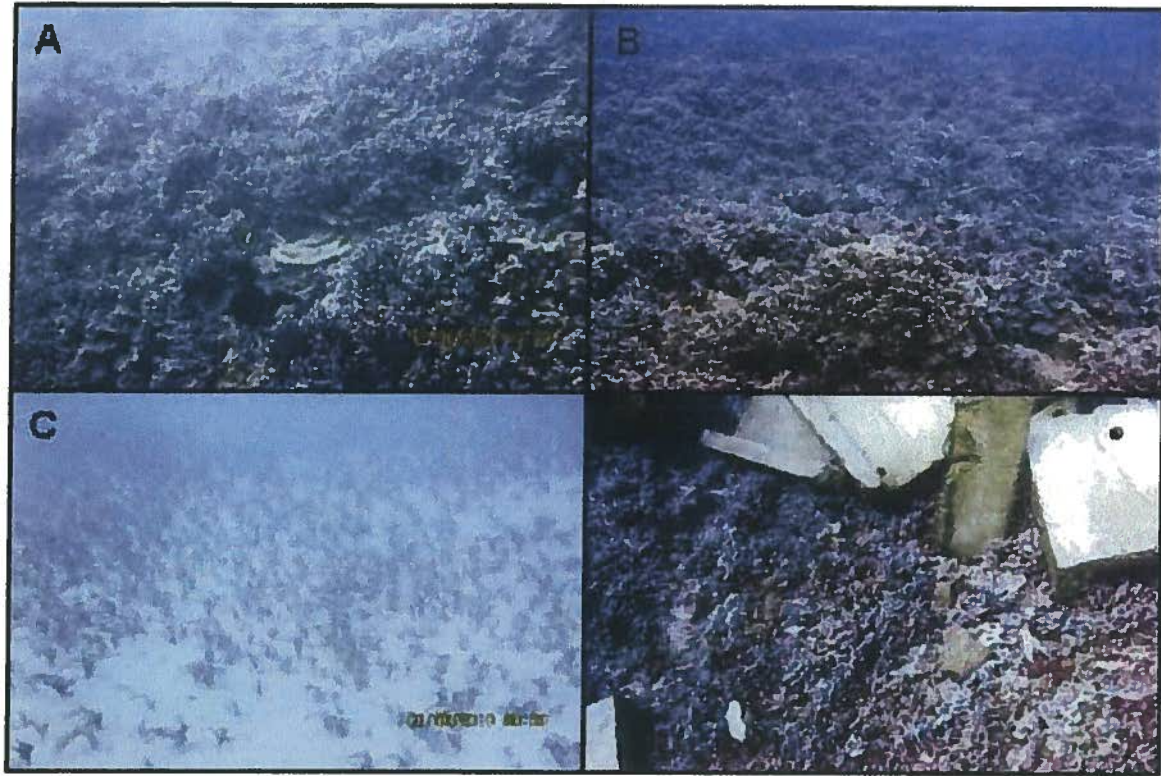
Figure 7. Representative photographs of the habitats and species in the area.

Coral cover was high (> 50%), and relatively homogenous across the main and patch reef sections. The coral community was predominantly composed of *Porites compressa*, encrusting and finger-like morphotypes of *Porites lobata*, and encrusting *Montipora capitata* (Fig. 7A, 7B). Colonies of *Montipora patula*, *Pocillipora meandrina*, *Pocillopora damicornis*, and *Pavona varians* were also observed. No larger coral colony mounds were noted and there appeared to be substantial coral fission which made identifying discrete colonies difficult. Broken pieces of *P. compressa* were observed in areas where modules had landed and then shifted and also where module fragments had rolled down slope (Fig. 1D, 5A, 5B, 6C). There was a limited abundance of reef cementing crustose coralline algae.

A) The reef showing several species and relative coral cover typical of all surveyed areas.

D) Fragments of broken *Porities compressa* coral seen commonly in most injured areas.

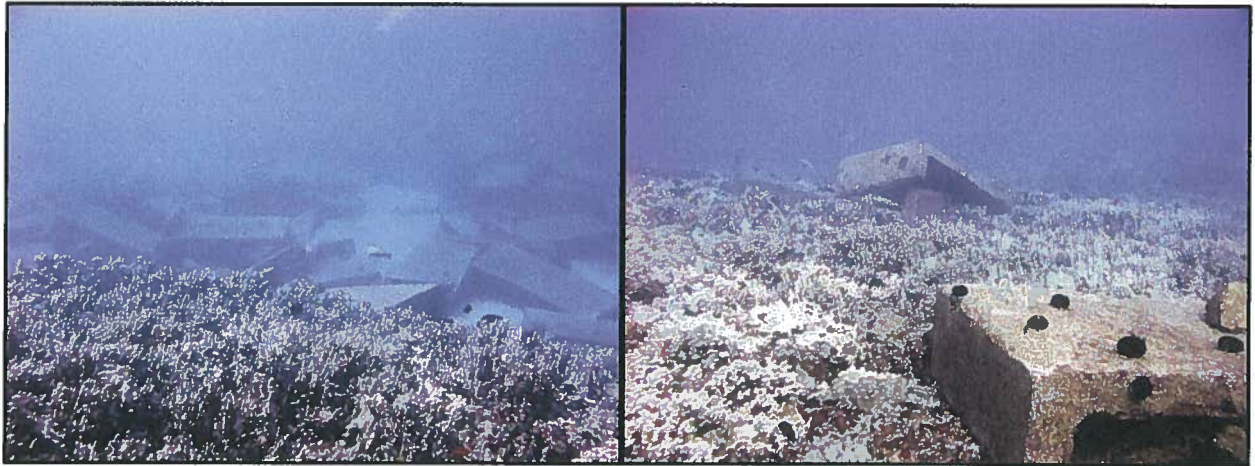
Pictures showing the Keawakapu reef beds with the Z-modules in the sand near the reef's edge, and some of the Z-modules sitting on the coral beds where they were accidentally deployed.

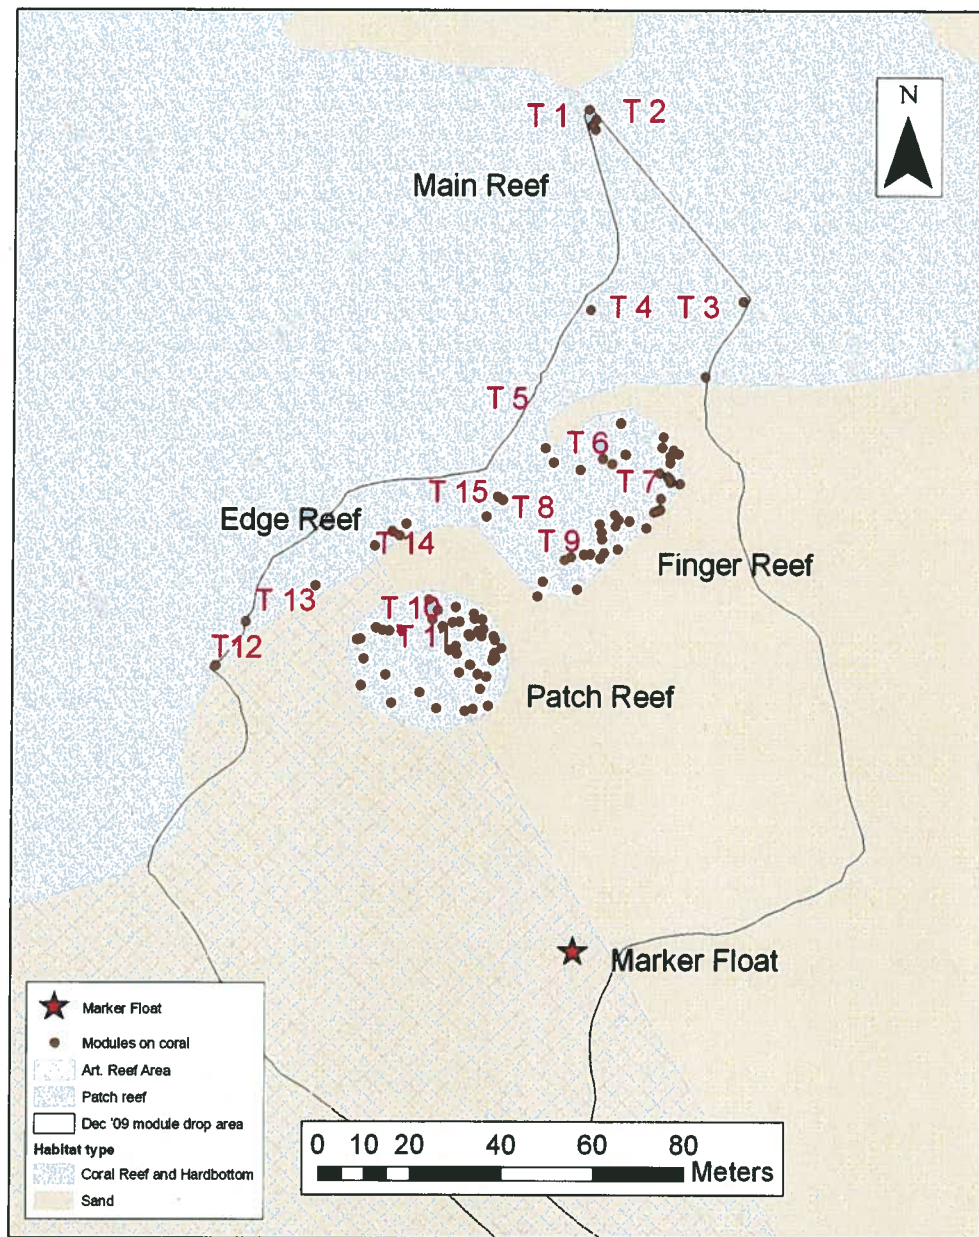
Figure 2: Map of the impacted reef area, with grey grid representing the designated artificial reef area, tan area representing sand, and the blue area representing coral reef habitat. Small dots are each of the 125 Z-modules currently sitting on reef habitat, red numbers represent the 15 reef assessment transects that were conducted on July 28 & 29, 2010, and the red star shows the marked final deployment site.

Table 1 shows the results of the damaged coral reef area assessment with the total reef area damaged calculated at 311.79 m². The majority (84%) of damage occurred on the patch and finger reefs (Figure 2 & Table 1).
